BROOME COUNTY WATERSHED FLOOD HAZARD MITIGATION PLAN

March 2016

BROOME COUNTY WATERSHED FLOOD HAZARD MITIGATION ANALYSIS

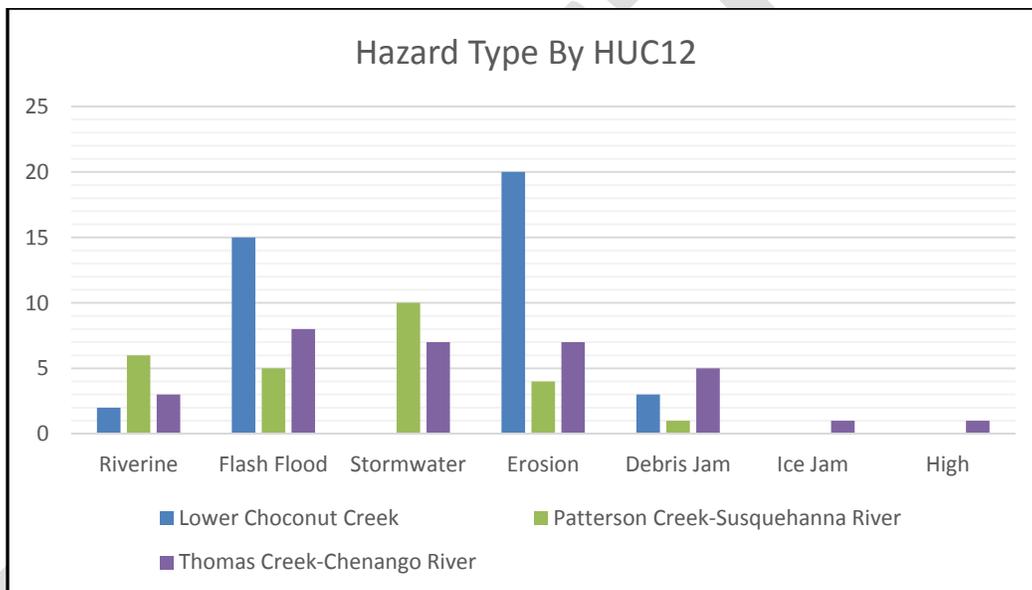
Figure 1: Bar Plot of Hazard Types in the Three Selected Watersheds

The number of each hazard types (7 total) of the three selected watersheds can be seen in Figure 1. Erosion and flash flooding are by far the most common flood hazards in the Lower Choconut HUC12. In Patterson Creek, stormwater, riverine and flash floods have roughly the same number of hazards, 10, 6 and 5 respectively. Thomas Creek has more flash flood hazards (8) than any other hazard while stormwater and erosion hazards have the same number (7). Patterson Creek HUC12 and Thomas Creek HUC12 contain four and six municipalities within their drainage areas respectively. There may be flood mitigation opportunities that will have benefits that cross municipal lines in these two watersheds. Lower Choconut Creek only contains the Town of Vestal and its downstream neighbor is not in Broome County so flood mitigation opportunities in this HUC12 may transcend county boundaries. A more detailed description of each watershed is included in Chapter 4.

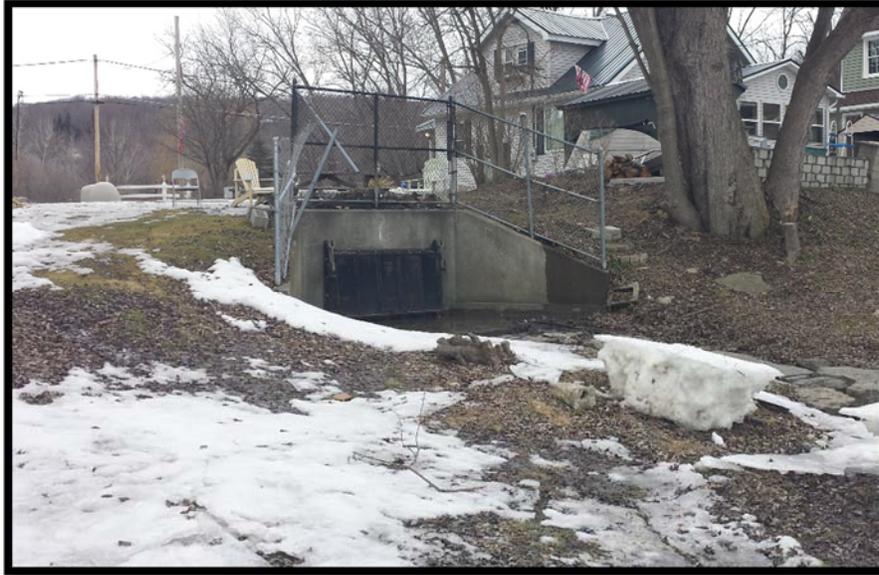
Looking West at the Stormwater Channel Outfall

The total length of the proposed berms is 2,100 feet and crosses 15 parcels and Merrill Road (per field observations, Aldrich Road as seen in B-27 does not exist in the alignment area). The 6' high earthen berm unit cost was increased from \$205 per linear foot to \$215 per linear foot because a 7' high berm will be required. Since there is room between the berm and adjacent homes and driveways, it is proposed that the Merrill Road profile be adjusted upwards to meet the crest elevation of the berm. The additional cost for this adjustment was included in the unit cost of the berm. Three pumping stations will be required to pump stormwater that during pre-mitigation conditions would drain into the Chenango River but now is trapped on the landward side of the levee. Pump Station "A" is located along an existing stormwater channel (see photo below) and drains approximately 20 acres, therefore the pump would be larger than the other two stations and more grading work is anticipated. Pump Station "B" is located landward of Alignment #1 and would drain less than 0.5 acres and will require only minor grading. Pump Station "C" would be draining less than a 0.5 acre of land and need only minor grading to direct flow towards the pumping stations. A cost to acquire a permanent right of way was calculated using the berm's footprint and a unit cost. The proposed mitigation costs are shown in Table 14.

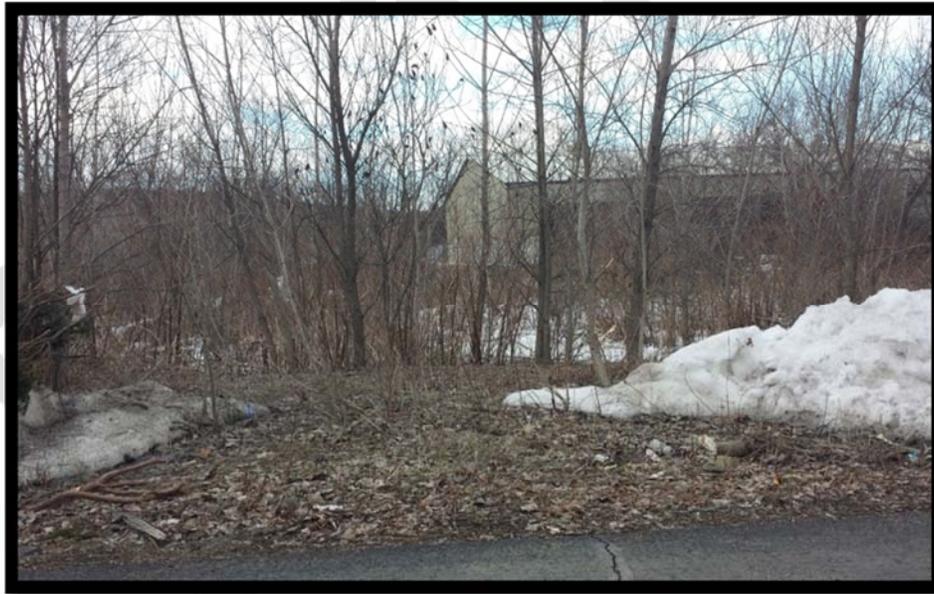
Looking East at the Town's Transfer Station the Proposed Flood Mitigation Work Site.

The total length of the proposed berm is 200 feet and it crosses two parcels. One parcel is owned by the Town of Chenango and the other is privately held. Field observations showed that the area between the two buildings is a low-lying area (as seen in photo below) that appears to be undevelopable which will reduce the cost of acquiring a construction right of way. The 6' high earthen berm unit cost was increased from \$205 per linear foot to \$300 per linear foot because a 12' high berm is needed. A pumping station will be needed because interior stormwater that during pre-mitigation conditions would drain to the Chenango River through the low-lying area would be trapped on the landward side of the levee. The pump station location will be near the proposed berm and a moderate amount of grading will be needed to increase the amount of storage area on the landward side of the berm. The grading and removal of material in this area will increase the amount of available interior storage volume of water. By increasing the amount of interior stormwater storage, the size and cost of the pumps can be decreased. The proposed mitigation costs are shown in Table 17.

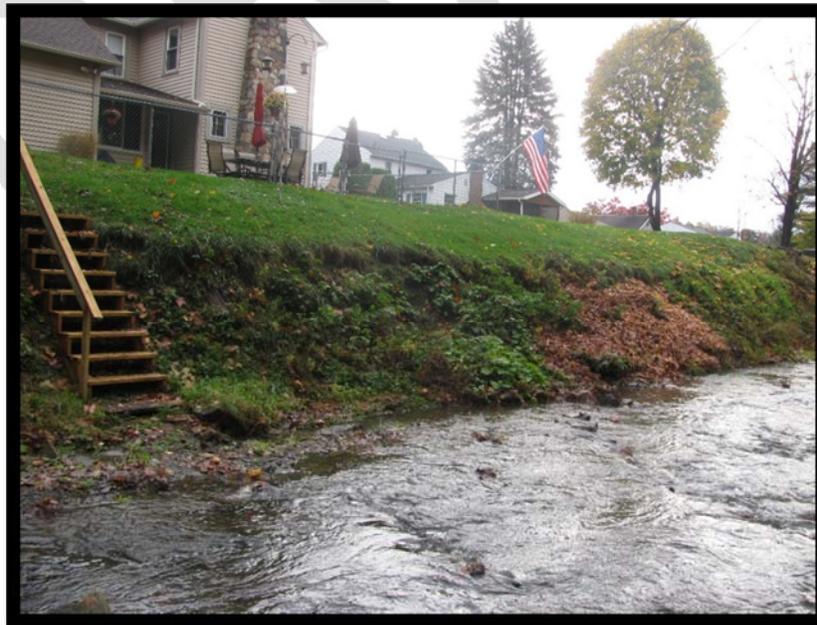
Mitigation Site 1 is located 100 feet upstream of the Smith Drive Bridge over Paterson Creek. There is one erosion hazard located at Mitigation Site 1 (B-36, Appendix B). The drainage area to Site #1 is 6.5 square miles whose largest land use type is forested area (53%). The drainage area contains 4.8% impervious cover (per 2011 National Land Coverage Dataset (NLCD)). -Patterson Brixius Grey Watershed 1 Flood Control Dam (State ID: 086-3457) is located upstream of Mitigation Site #1 which reduces flood discharges by storing flood waters for 4.5 square miles (70%) of the watershed. The dam is a high hazard class "C" dam and was studied by detailed hydrology and hydraulic modeling methods. The erosion hazard consists of a 600' long eroding left bank (east bank of the creek) that is composed of a silty sand soil material with bank angles that approach near vertical and average 8' in height. There is very little to no riparian corridor along the top of the stream bank and therefore there is very low root density along the stream bank toe to provide bank cohesion and resistance to erosion. A typical bank section can be seen in the photo below.

Looking East at Erosion Hazard at a Private Home.

A stable bank angle for this material type is a 3 horizontal to 1 vertical. A silty sandy soil and low root density (such as planted with sod) will begin to erode when velocities exceed 1.0 ft/second (referred to in this report as incipient velocity).

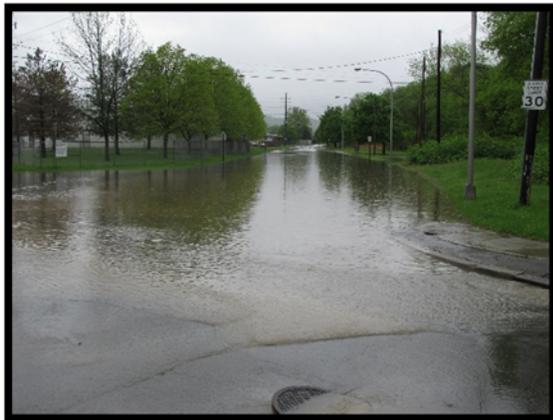
Figure 3: Robble Ave/Clark Street, view east

Frequent flooding occurs along sections of East Franklin Street, Clark Street, Oak Hill Avenue and areas within the Huron Campus during periods of heavy rainfall. The area along East Franklin Street and Clark Street is the area that is most chronically affected with street flooding occurring even after moderate rainfall events. The photos below were taken on May 9th, 2014 after a rainfall event of approximately 1.3 inches of total rainfall. Residents and Huron Campus staff have reported that the existing stormwater sewer system in these areas frequently back up through the inlets and manholes, resulting in street flooding and sheet flow flooding of adjacent homes and properties. Ponding of stormwater within the travel lanes of public roadways also creates a public safety issue and potential liability to the Village of Endicott. The affected areas along Clark Street and East Franklin Street require the placement of barricades and flares by Village Police to prevent vehicular/pedestrian traffic from entering flooded areas. It is estimated there are 4,000 one-way vehicle trips on Clark Street and East Franklin Street.
